ENVIRONMENTAL ASSESSMENT REPORT FOR SEAGRAPE EQUITIES, DBA JOHNNY LIME, LLC ESTATE EMMAUS PARCEL #8-1

CORAL BAY, ST. JOHN U.S. VIRGIN ISLANDS

JUNE 2021

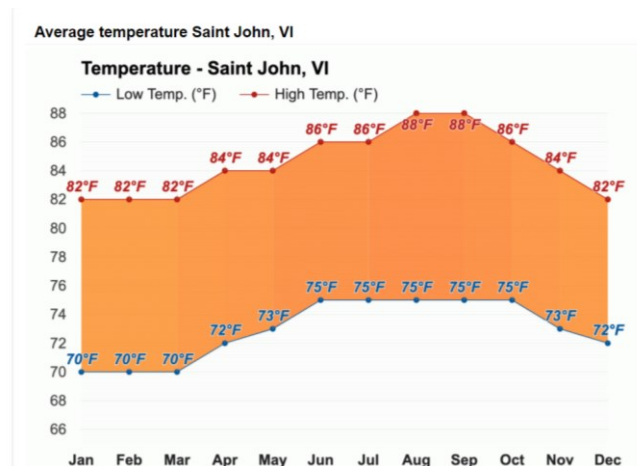
Figure 6.01.1 Average Temperature www.weather-us.com

The difference between the mean temperatures of the coolest and warmest month is only 5 to 7 °F. The highest temperatures occur in August or September and the lowest are in January or February. The highest average daytime temperature in the warmest months is about 88 ° F, and in the coolest months is in the low 80's. Nighttime lows are usually in the mid 70's during the warmer months and in the high 60's during the cooler months (USGS 1998).

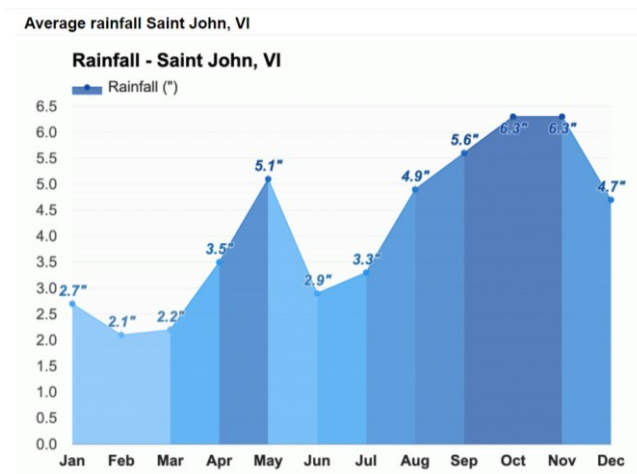
Figure 6.01.2 Rainfall St. John, U.S. Virgin Islands, www.weather-us.com

substantially at various locations throughout the island. Throughout the year, there are 156 rainfall days, and 49.69" (1262mm) of precipitation is accumulated. Leeward aspects receive greater amounts of rain because clouds develop over the slopes daily. In general, days have a higher incidence of rainfall than nights. St. John's wettest period generally is from September to November, and the driest period is from January to June. Occasionally, intense rainfall occurs during the drier period (USGS 1998).

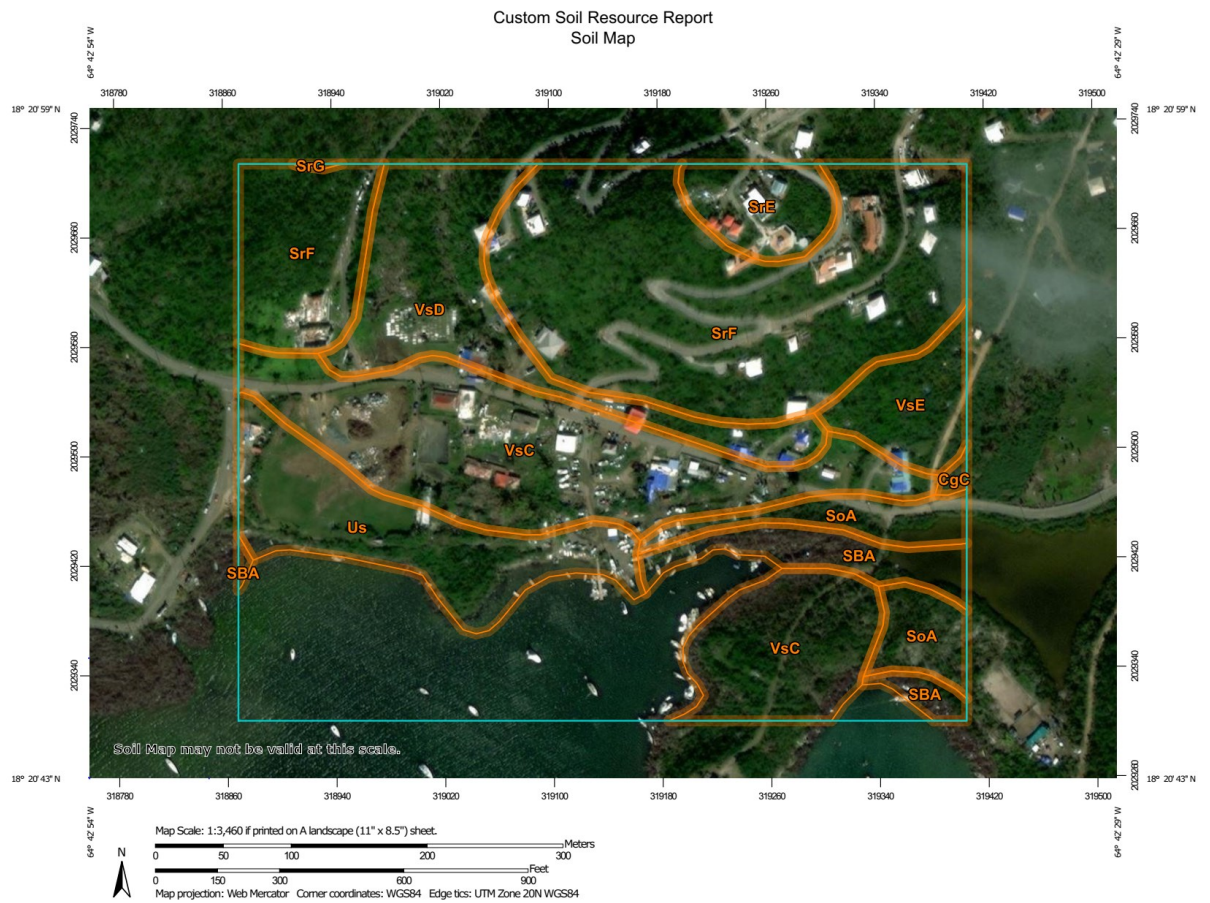
Figure 6.02.3 USDA-NRCS Soils Map

Two soil type are present on the project site according to the Custom Soil Survey of the United States Virgin Islands. Southgate-Rock (**SrF**) outcrop complex, 40 to 60 percent slopes. These soils are found on mountain tops hillslopes, mountain slopes, and ridges and often have as much as 40% exposed rock outcroppings. This soil is located on the northern portion of the site and includes the area to the north of the parking area. The other soil type which is found along the roadway and parking lot is Victory-Southgate complex (**VsD**), 12 to 20 percent slopes, very stony. These soils are found on hillslopes and ridges and have paralithic bedrock between 20 to 40 inches and lithic bedrock 40 to 60 inches below the surface. Soil where present will be very gravelly loam. Soils are well drained.

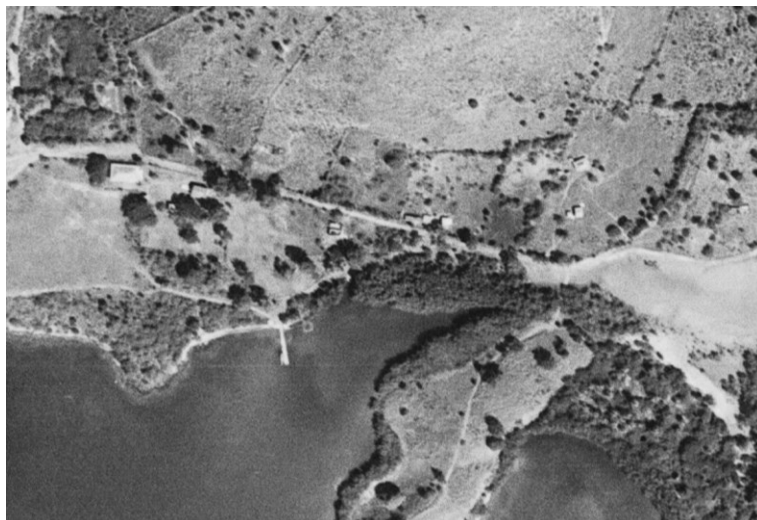
Northern Coral Harbor 1954

The site was undeveloped and in use as pasture land in the 1950's. The winding roadway up the hillside was cut in the 1980's and the existing 3 story building was constructed between 1999 and 2002.

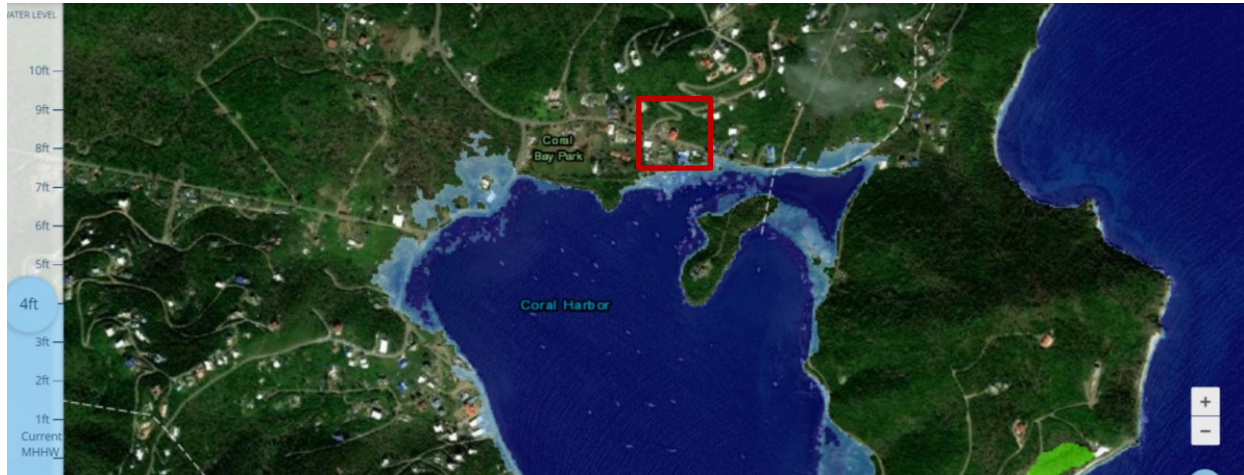
Figure 6.03.6 Sea Level Rise Map (<https://coast.noaa.gov/slr/#/layer/slr/4/-7231238.867507785/2076551.6197419522/15/satellite/none/0.56/2050/interHigh/midAccretion>)

According to NOAA's Sea Level Rise Viewer, when sealevel rises as much as 4ft it will have a significant affect of on the adjacent property

The project site will not be affected by sea-level change.

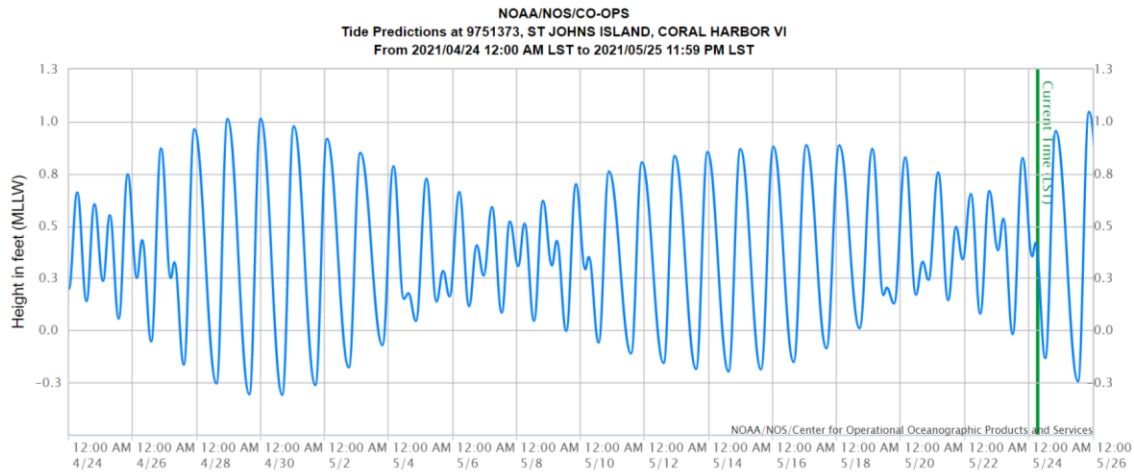
Figure 6.05.1 Tides in Coral Harbor, St. John

The Virgin Islands coastal areas are not subject to significant tidal ranges or tidal currents. Due to the small size of the islands, the sea flows around the island causing an average tidal height of only a few inches and maximum change of only a little over a foot. Only very narrow intertidal zones are found because of this lack of tidal amplitude and the steepness of the island rising out of the sea. The tides within Coral Bay are primarily semi-diurnal in nature, with two cycles of high and two of low water every 24 hours. The mean tides range from 0.72 feet to 0.9 feet and the spring tidal ranges reach up to 1.3 feet (IRF 1977).

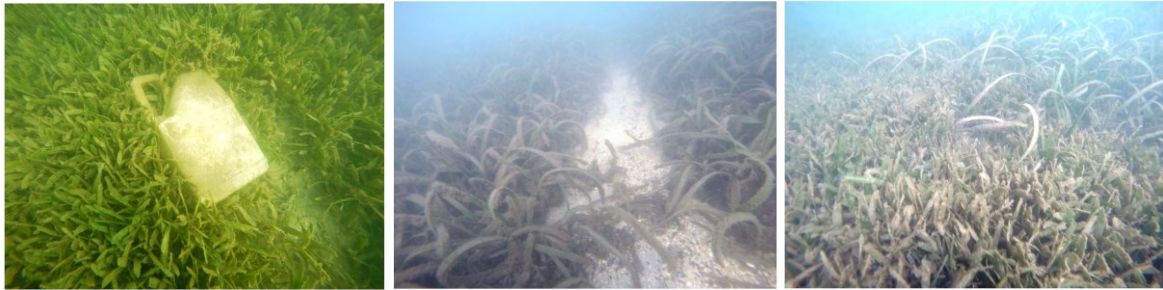
Halophila stipulacea and garbage – *Thalassia testudinum* and an anchor scar – *H.stipulacea* and *T. testudinum*.

The NOS Benthic Habitat Map shown above shows the area as a mix of continuous seagrass beds as well as 50-70% coverage seagrass beds. The Submerge Aquatic Vegetative (SAV) is fairly accurate, however a significant portion of the SAV is macro-algae and the invasive seavine.

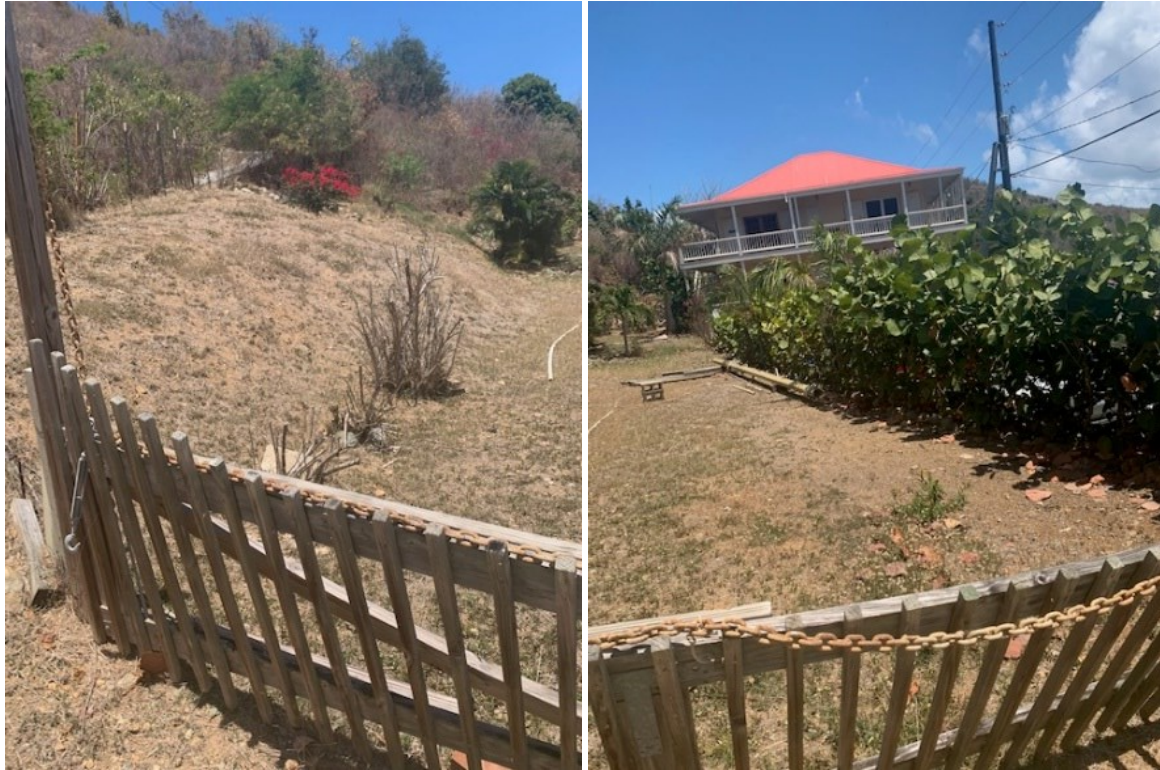
Overgrown gravel drive into the property above the small retaining wall. There are dead plants on the left north of the drive and a row of seagrapes on the upper side of the retaining wall.

The site has been cut and graded and there is a graveled drive into the site above the small retaining wall, and a patio on to the grade area. There is a concrete roadway which extends up the steep

hill to the west and north side of the property. There is exposed loose rocks on the top and base of the steep slope.

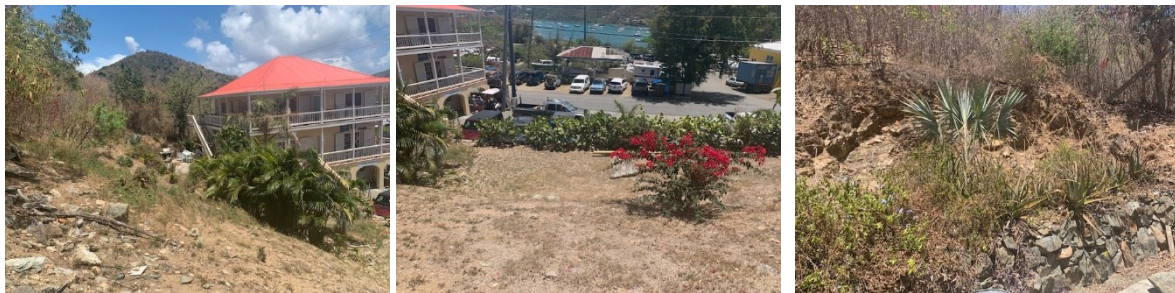
There are planted palms, bougainvillea, and aloe within the yard.

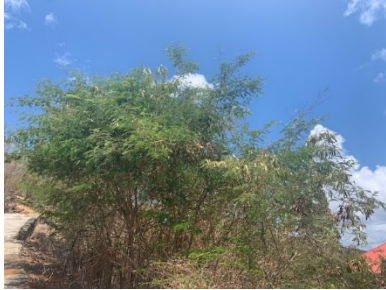
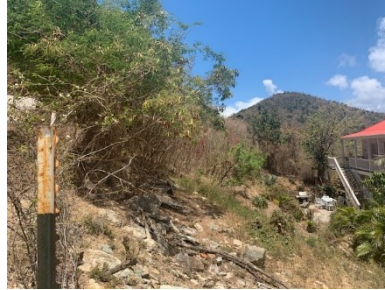
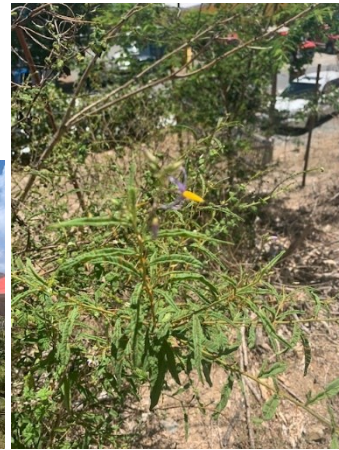
Outside the wire fence are opportunistic species including a *Solanum conocarpum*.

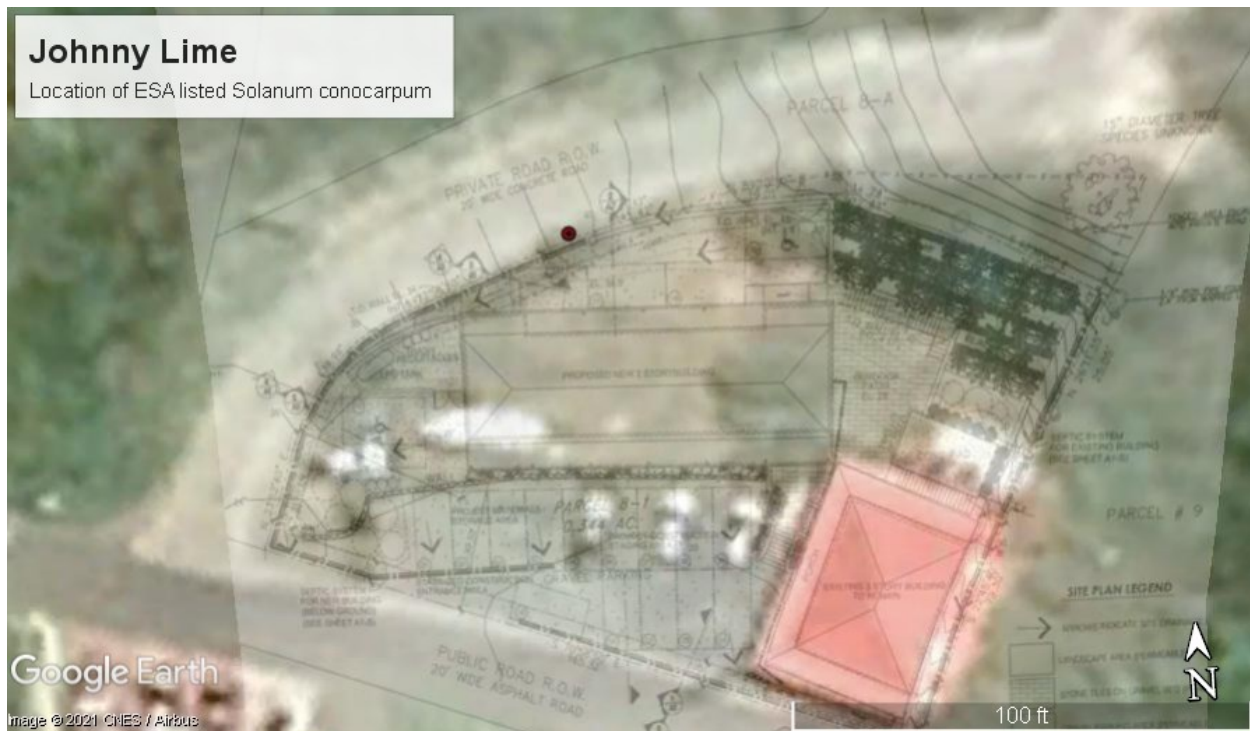
Figure 6.09. Location of *Solanum conocarpum* outside the fenceline.

There are three endangered plants which are known to occur in the Coral Bay area of St. John, *Calyptanthus thomasiona*, *Solanum conocarpum* and *Zanthoxylum thomasionum*. A *S. conocarpum* occurs outside the fence line and will not be impacted.
